MACH 6 ELECTROFORMED NICKEL NOZZLE REFURBISHMENT

FNAS Investigation of Ultra-Smooth Surfaces

NAS8-38609

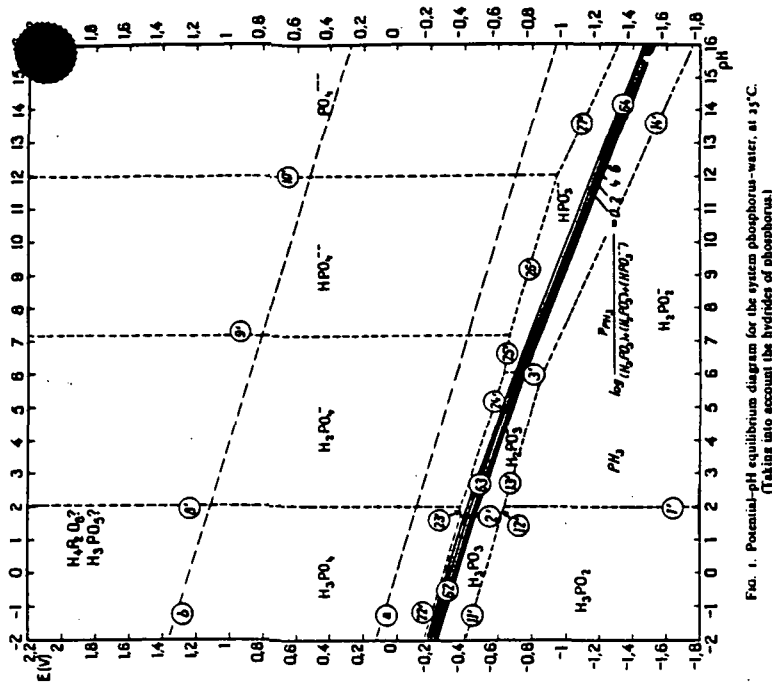
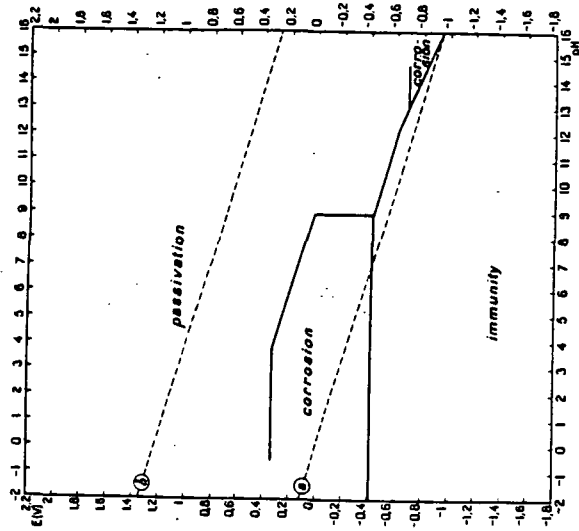
Fig. 1 Deposition and Corrosion of Nickel - phosphorous

Theoretical conditions for the formation of nickel by the reduction of Ni^{++} ions by hypophosphites.
(For solutions containing 0.6 g Ni^{++}/l .)

Theoretical domains of corrosion, immunity and passivation of nickel, at 25°C.

FIG. 1. Potential-pH equilibrium diagram for the system phosphorus-water, at 25°C.
(Taking into account the hydrides of phosphorus)

Probable experimental conditions of corrosion, immunity and passivation of nickel,
in solutions not containing chloride.

Nickel metal is subject to passivation at high oxidation potential in an oxidizing media. Phosphorous will actually improve this oxidation resistance to corrosion in the general environmental sense. However, by increasing the oxidation to much higher values than would be normally encountered in any environment, a reversal takes effect. The phosphorous alloy will then begin to dissolve while the pure nickel will further passivate. Since the nickel was encased in stainless steel, the nickel would remain slightly anodic when immersed in solution. This is due to the galvanic coupling and the noble nature of the nickel-iron-chromium alloy casing (Fig 1). Tests were performed on nickel plated, nickel-phosphorous over-plated samples. By using a very concentrated nitric acid solution it was possible to remove the alloy coating from the pure nickel deposit on these samples. Above 65% nitric acid (commercial azeotrope) the pure nickel dissolution was less than 0.0001 inch/Hr. Thus the decision to strip the part was agreed upon.

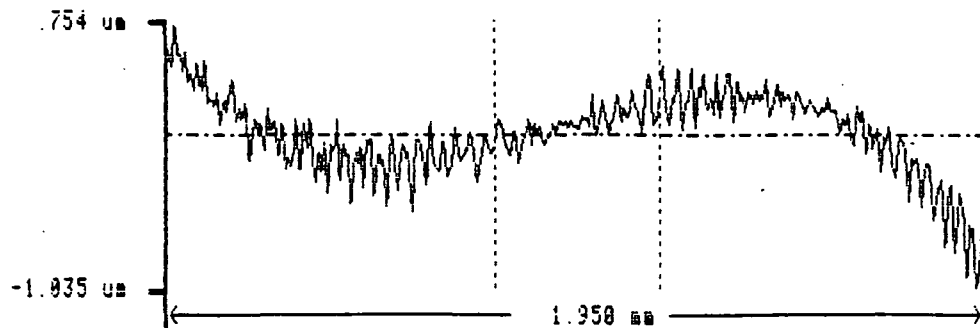
Mode	Traverse Length	Reference	Ignore
UNFILTERED	2.0 mm	CONVEX	0 %
NASA NOZZLE FINAL POLISH 1-.002

Peak To Valley = 1.789 um

Diamond Stylus 2 mm scan, Waviness Apparent;

Amplitude	=	+/- 0.900 μ m
Period	=	1.000 mm
RA	=	0.210 μ m
RMS	=	0.274 μ m
Peak to Valley	=	1.789 μ m

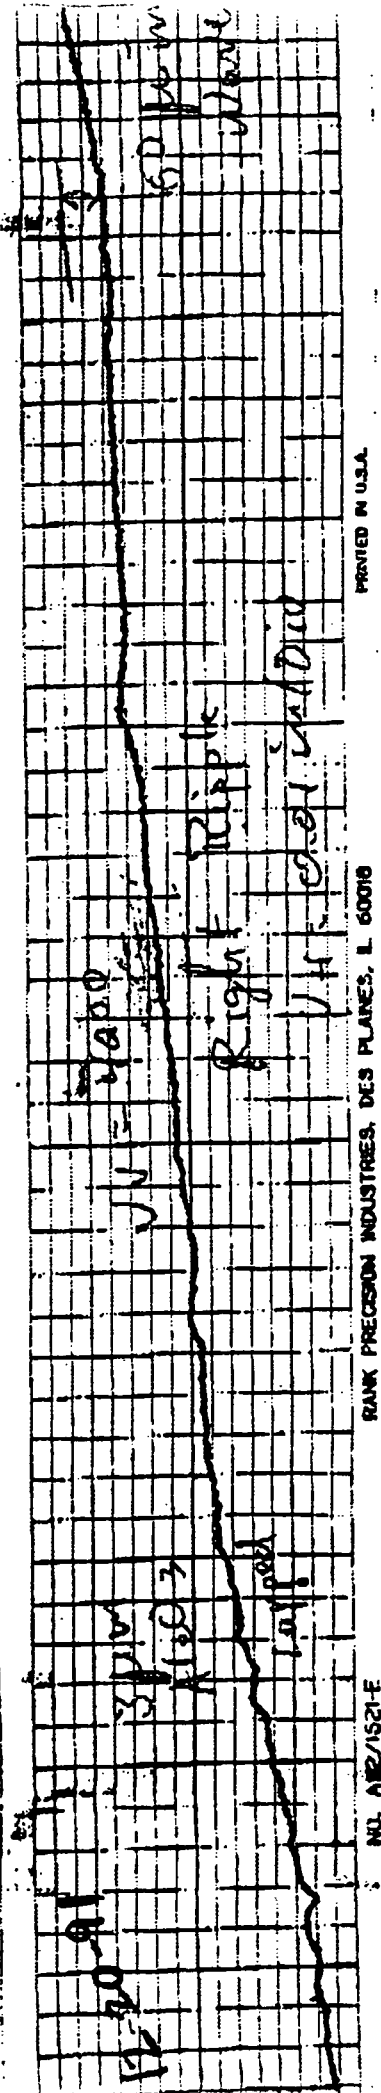
Fig 5a
 Rippled Area
 1.5 Hours Lapping
 Polish #2
 12-20-91

Right "Rippled" side After an Additional
 1.5 Hours Polishing with 5 μ m Compound
 Followed by 1.0 Hours with 3 μ m Compound

Vertical = 25 μ m/Div

Upon attaining a reflective surface it was evident that the nozzle had a discrepancy not apparent at the time of inspection after plating. About 15 degrees off each side of the streak of dull plating mentioned previously, a series of low period waves were observed. These waves were evidently of two frequencies and were related to the solution transport in the nozzle as the solution was slowly pumped upward through the nozzle. Subsequent profilometric inspection in the throat region showed the forward eight inches of the nozzle to be better than the remaining 32 inches. The waves in the throat were about one micrometer in height with a period of about one millimeter. The waves back into the nozzle were worse but could not be measured with the existing profilometer available to UAH. The small CCD camera previously used to view the inside of the nozzle could not resolve the height of the defects. These waves were still evident after sufficient lapping to polish the surface of the surrounding material. Due to an extremely tight schedule resulting from the rework requirements, the decision was made to ship the part for testing in place at Langley. See Figures 3 and 4.

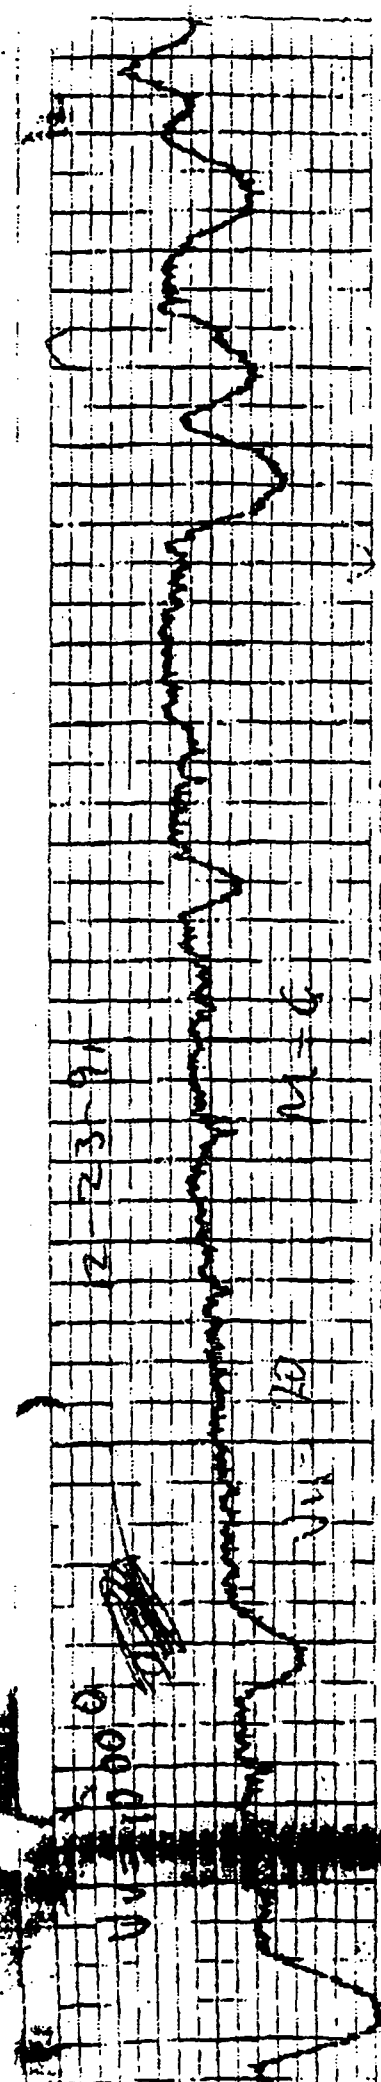
Vertical Scale = 10μ inch/Div Horiz. = 0.01 inch/Div
 Total Lapping Time Exceeds 12 Hours
 Including 1μm Polishing Compound
 Fig 561 9.5 ± 1.1 CA 0.5 inch 12-23-91

Right Side "A" Eight Hours Lapping with 3μm Compound

Left Side "B" Eight Hours Lapping with 3μm Compound

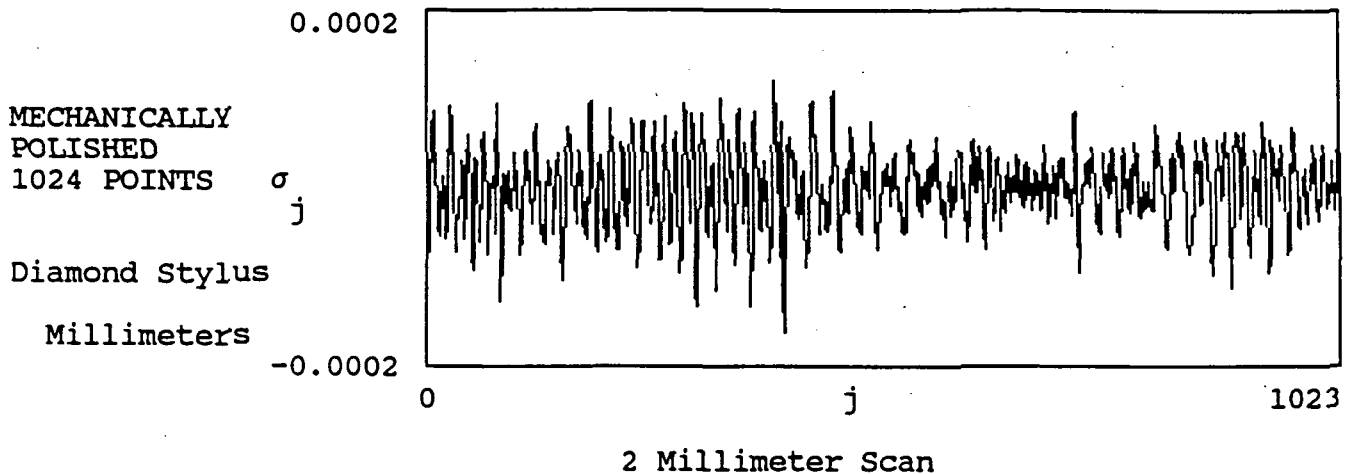
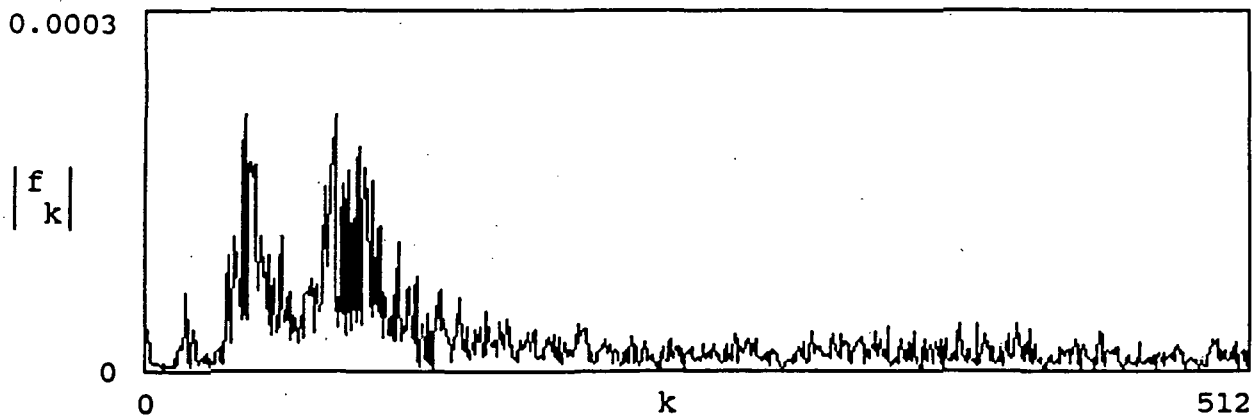
Fig. 6a Frequency Analysis of Polishing Data
Second Polish - Note Frequency Content

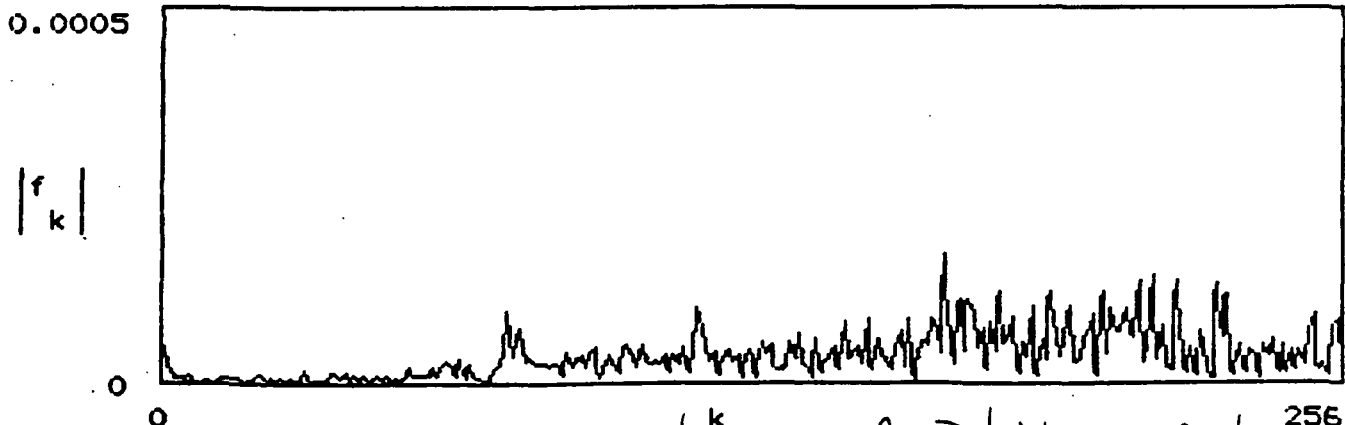
Fig 6 C Frequency Analysis^k of Polishing Data
Third Polish - Note smoother Freq. Spectrum 256

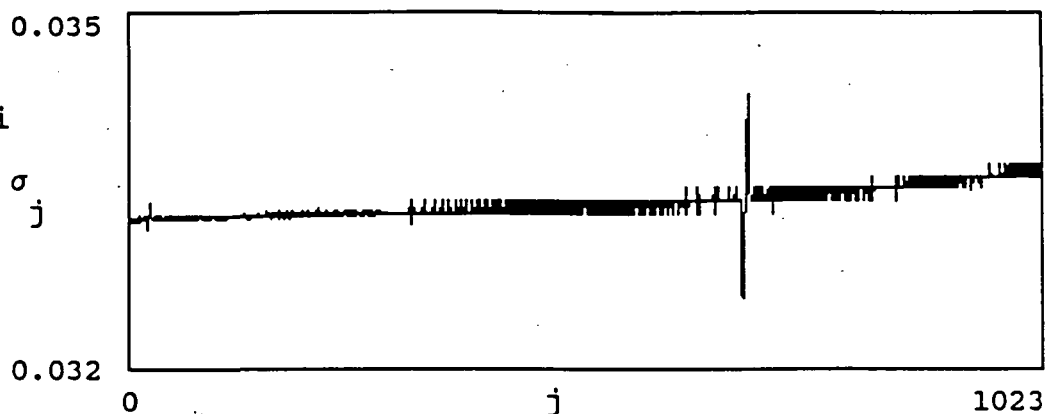
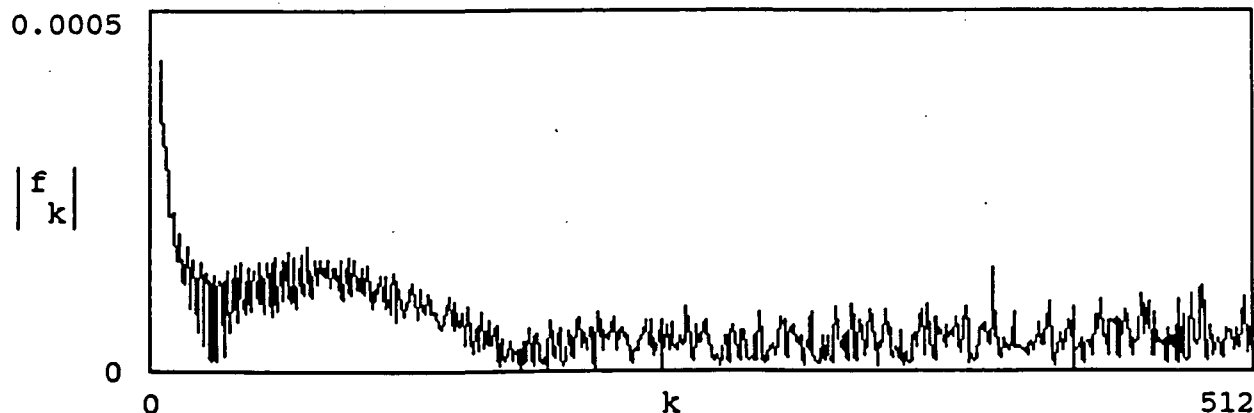
Fig. 6 f1

Analysis of Stylus Motion (Second Polish)
Note correlation to
disturbance 6e-1 to 6e-3 (Ruby Stylus)

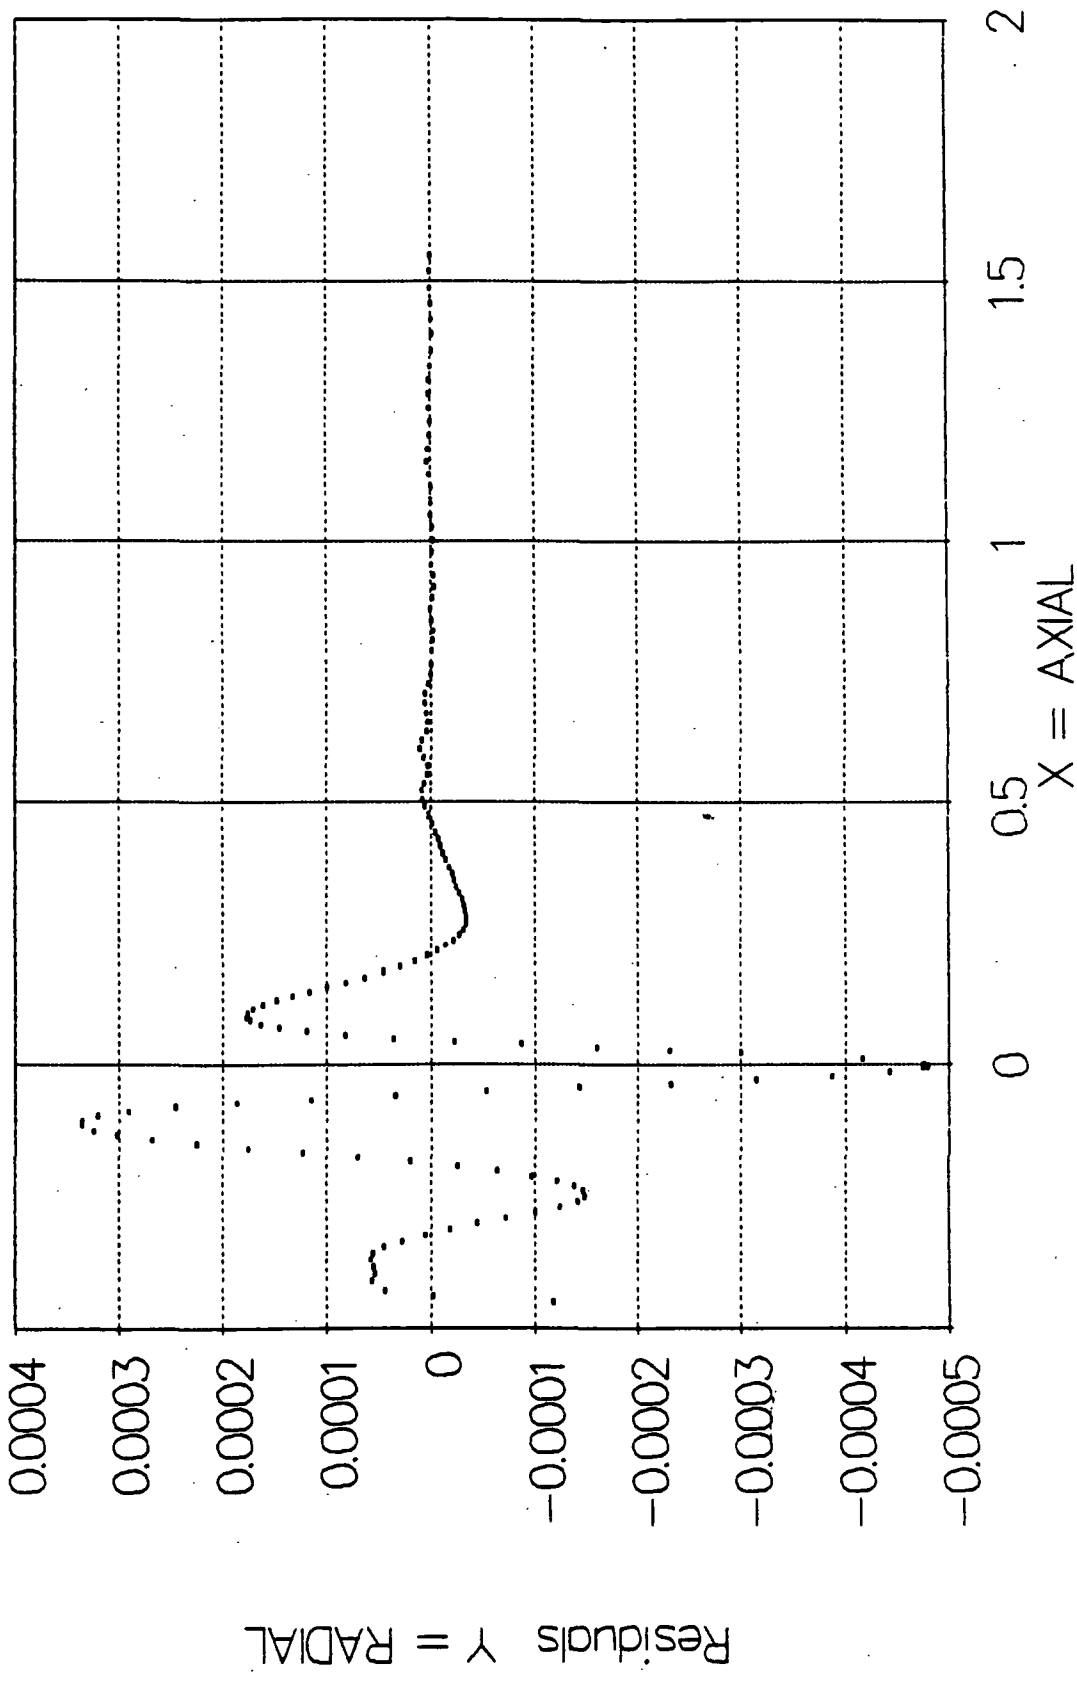
Fig 7b Residual Error at Minimum (Original Data)

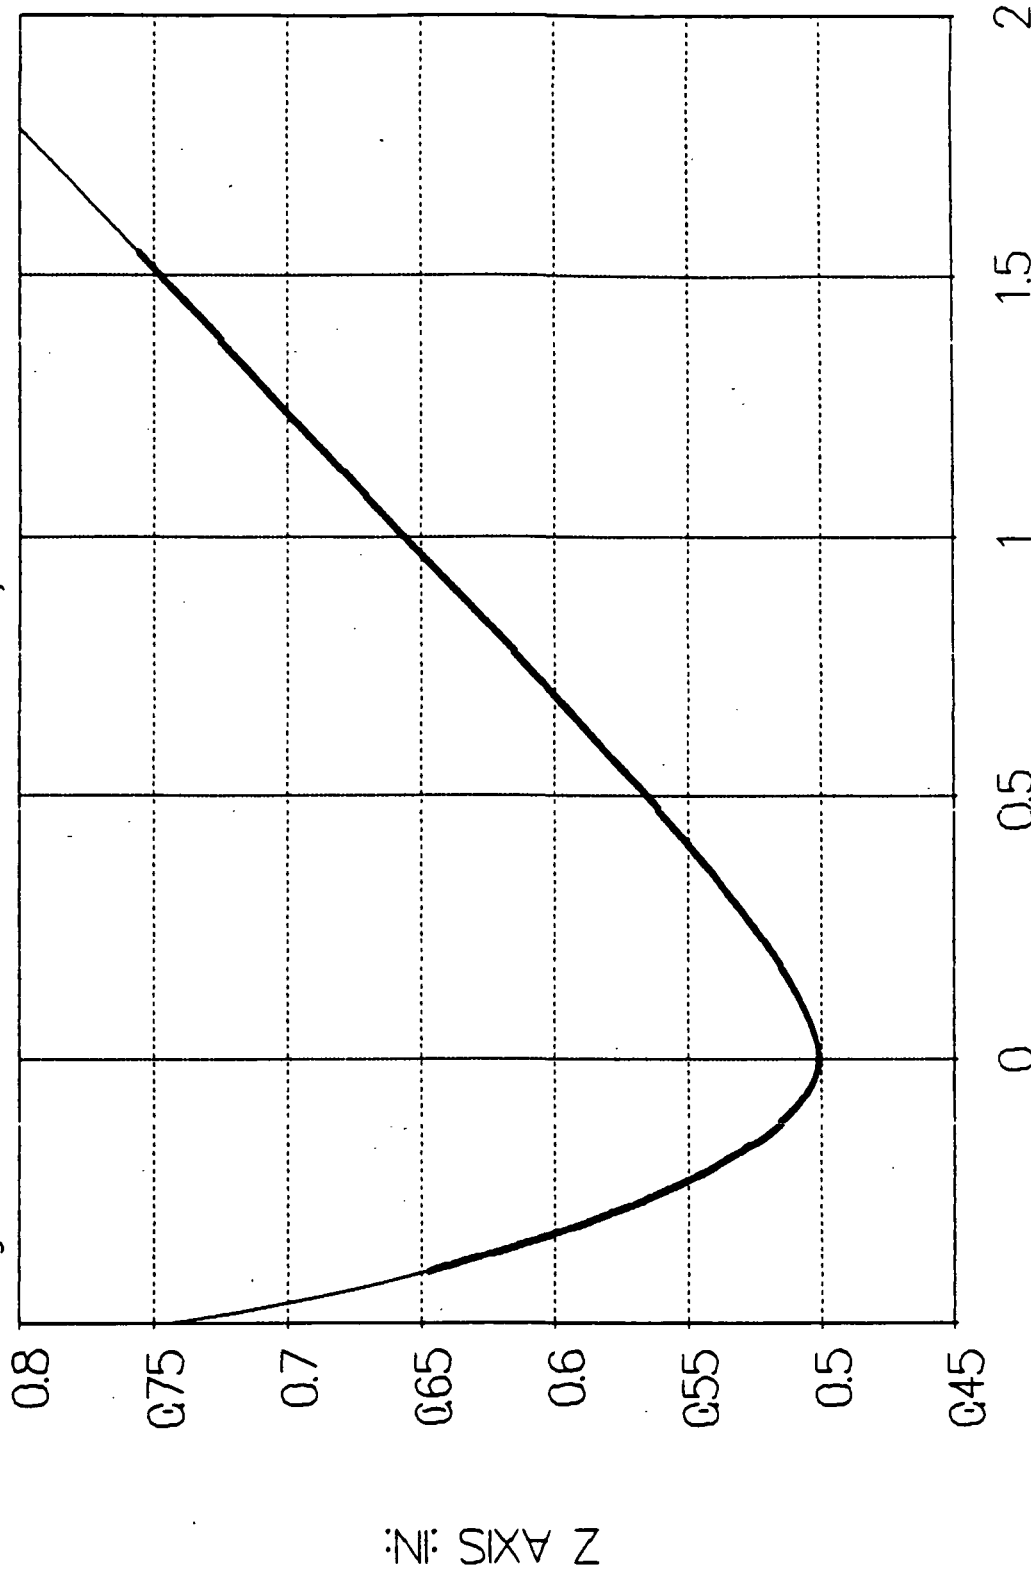
1 Eqn 221 $y=(a+cx+ex^2+gx^3+ix^4+kx^5)(1+bx+dx^2+fx^3+hx^4+jx^5)$ $r2=0.9999983857$
 $a=0.50180714$ $b=5.1375467$ $c=2.5758581$ $d=14.132047$ $e=7.7188703$ $f=9.4150694$
 $g=6.404223$ $h=-2.074745$ $i=1.8994291$ $j=-0.9558232$ $k=-1.6072757$

Fig 7d Polynomial Fit (Measured Data)

After the last polishing effort it was noted that the deviation of the measured actual part surface from the data set was about 0.0006 inches within an inch measurement which exceeds the print requirement. This was a single gradual slope change over the measured distance. This was not resolved until the part was shipped. It would have been very difficult to have corrected this error due to all the lapping using the two different tools. To correct for this it would be mandatory to have the inspection at the lapping site for frequent measurement and analysis. This was considered, but not permissible by the University due to other commitments for the equipment.

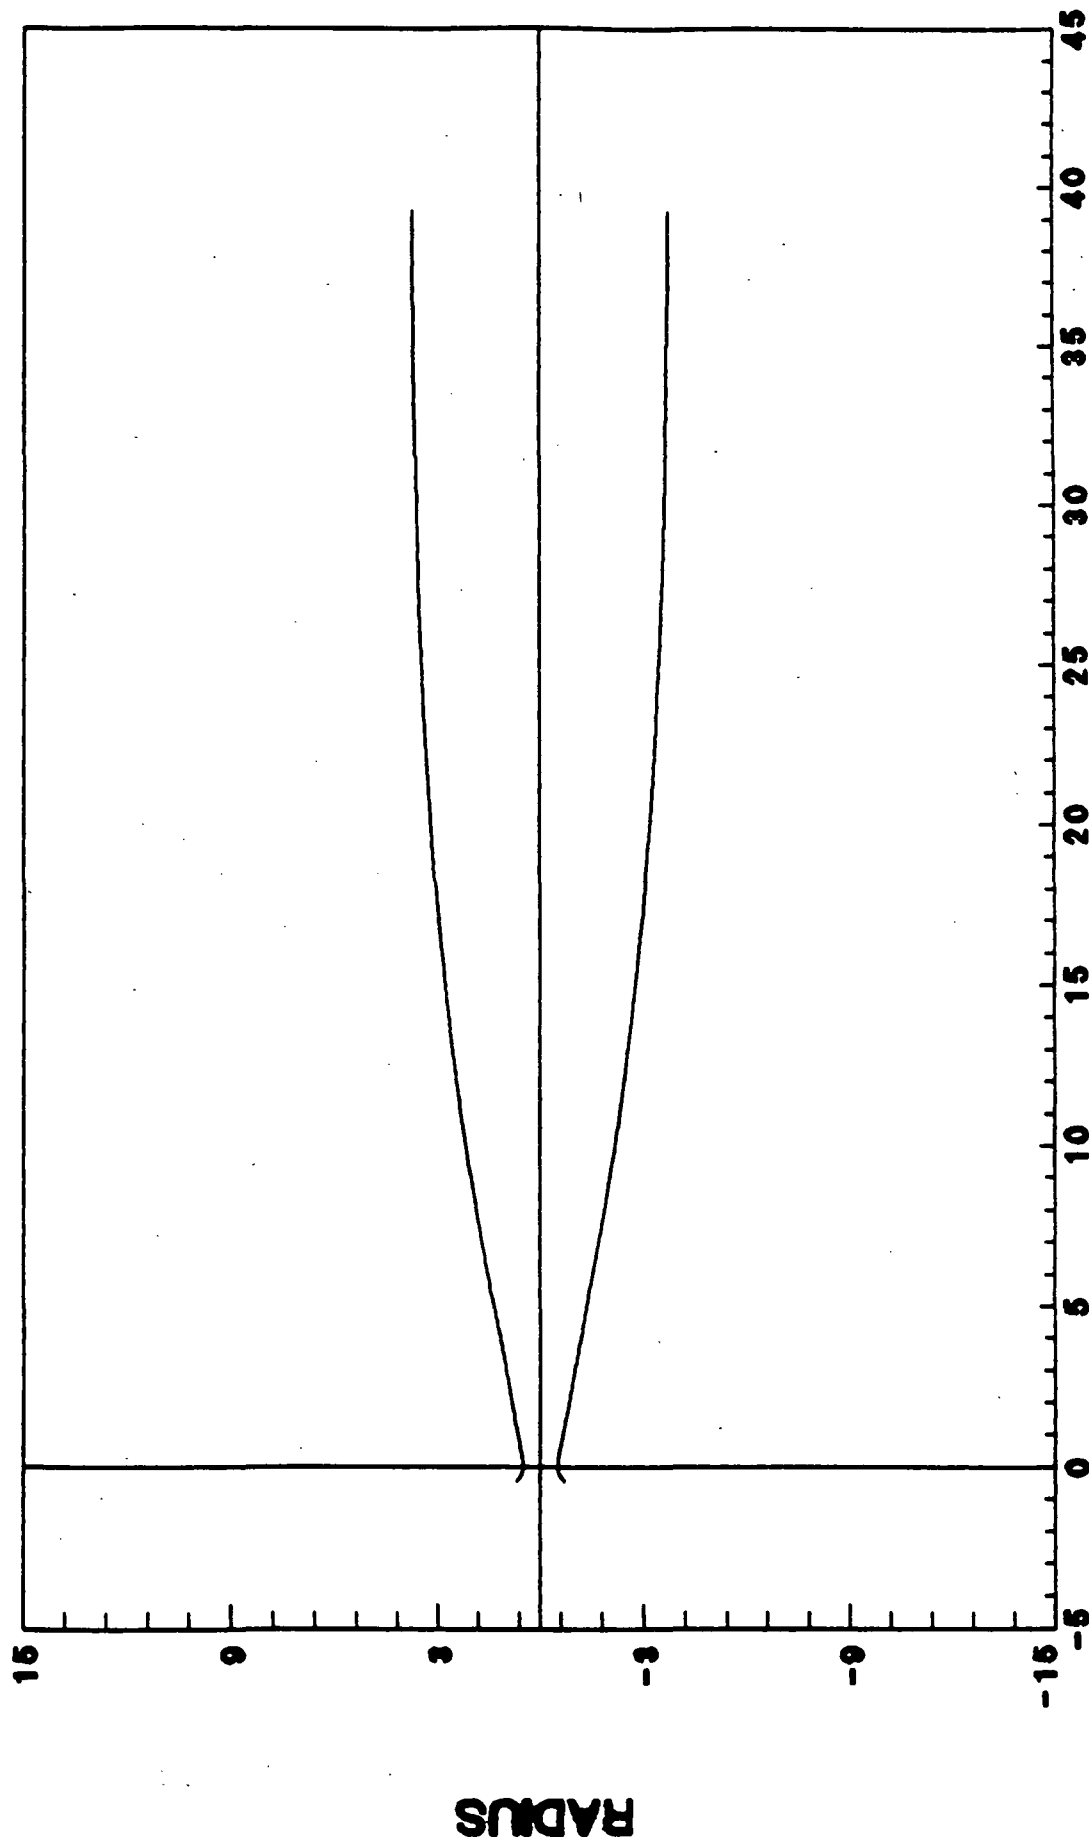
Fig 79 Original Data LENGTH

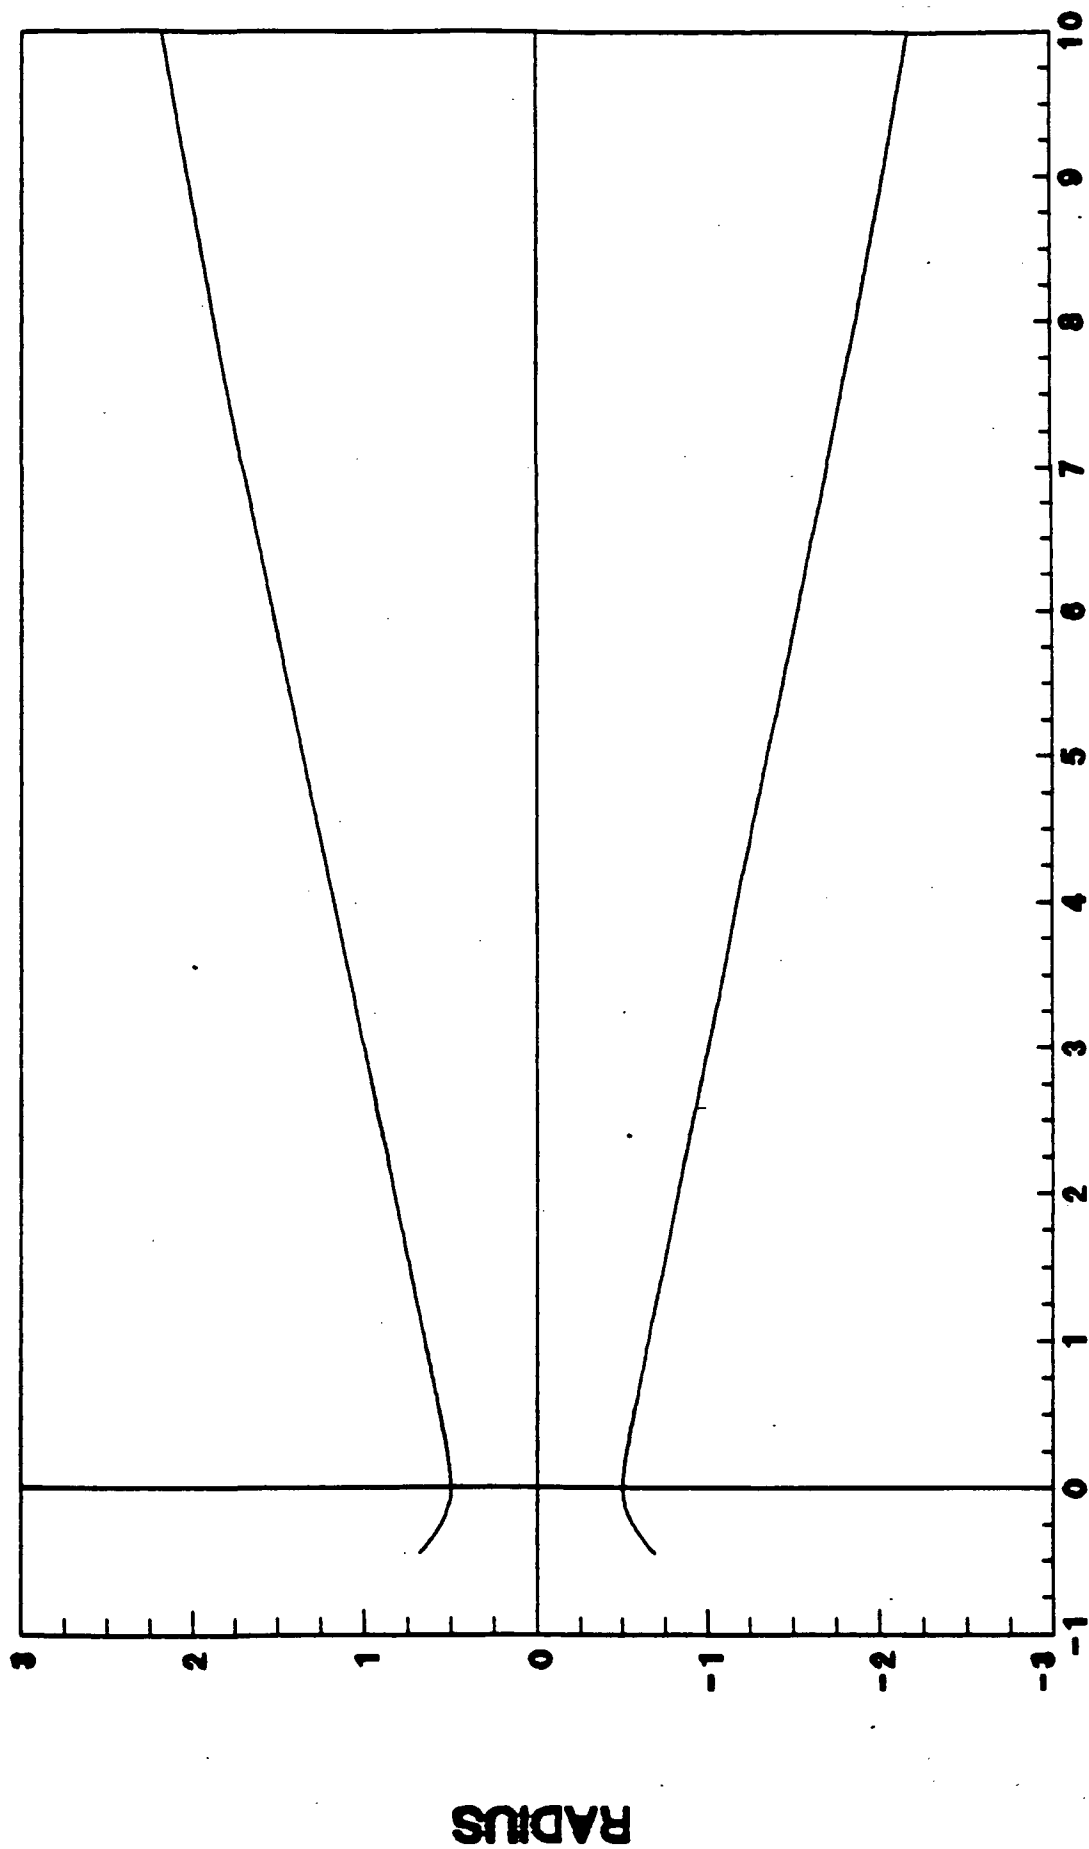
Fig 7h Original Data LENGTH

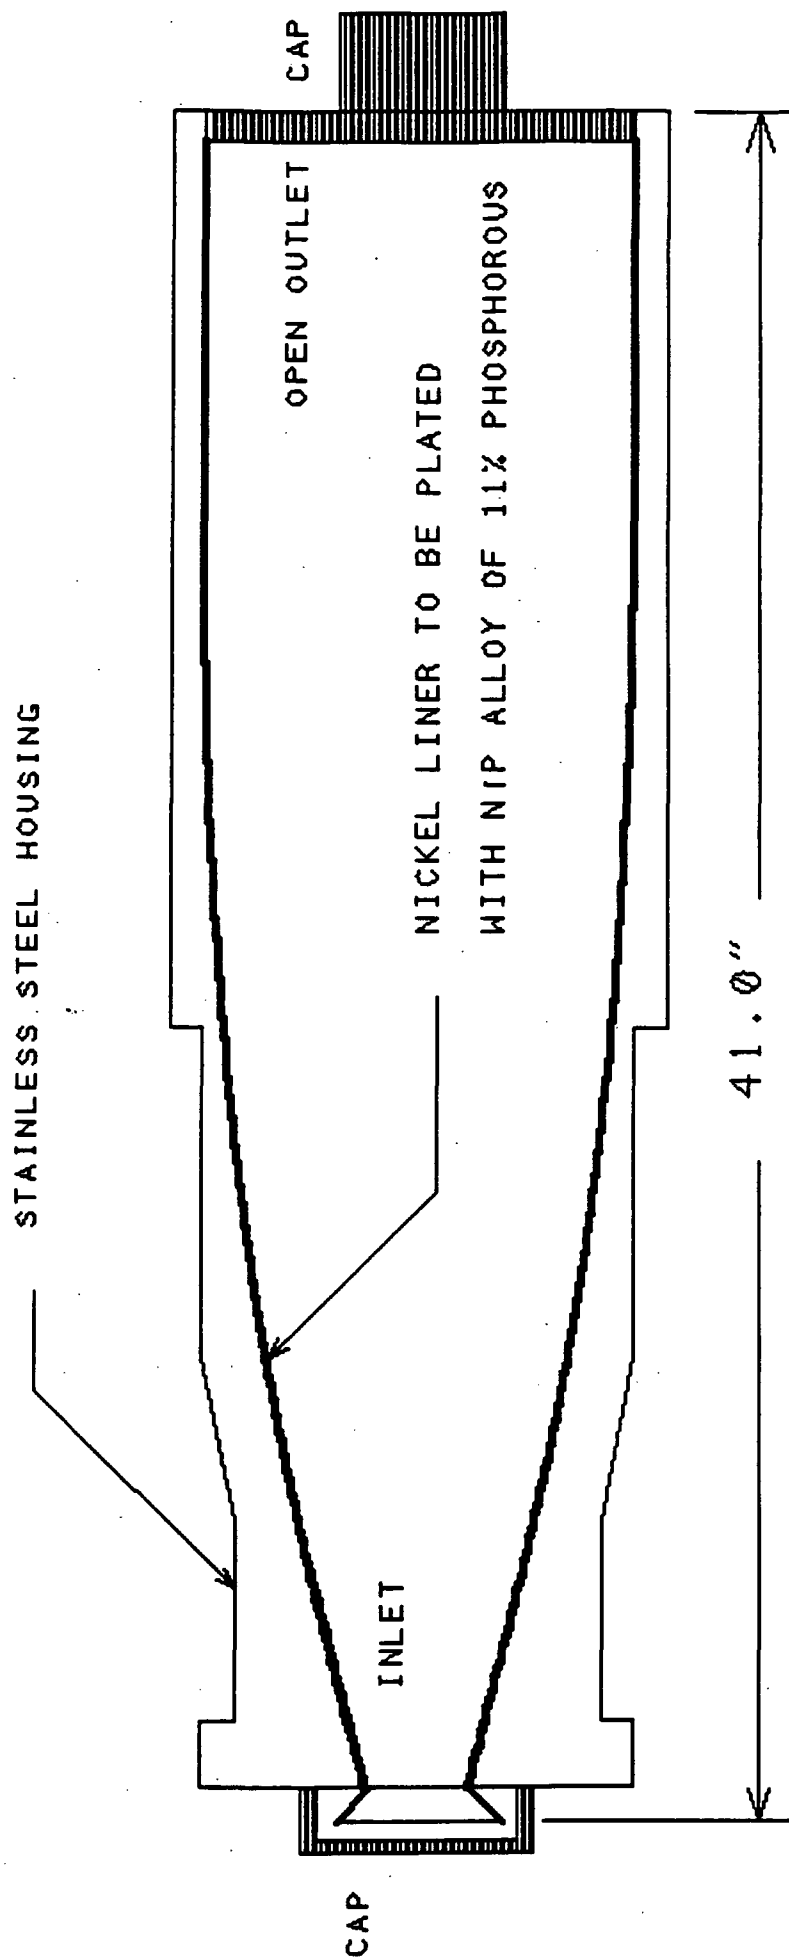
INLET HAS FRAGILE ROLLED LIP
WHICH MUST BE PRESERVED.
UNIT IS AXISYMMETRIC.
PLATING TO BE 0.0015 THICKNESS.
